# *Operation* **UPSHOT-KNOTHOLE**

Project 21.2

**EFFECTS OF AN ATOMIC EXPLOSION ON TWO TYPICAL  
TWO-STORY-AND-BASEMENT WOOD-FRAME HOUSES**

Federal Civil Defense Administration  
Washington, D. C.  
September 1953

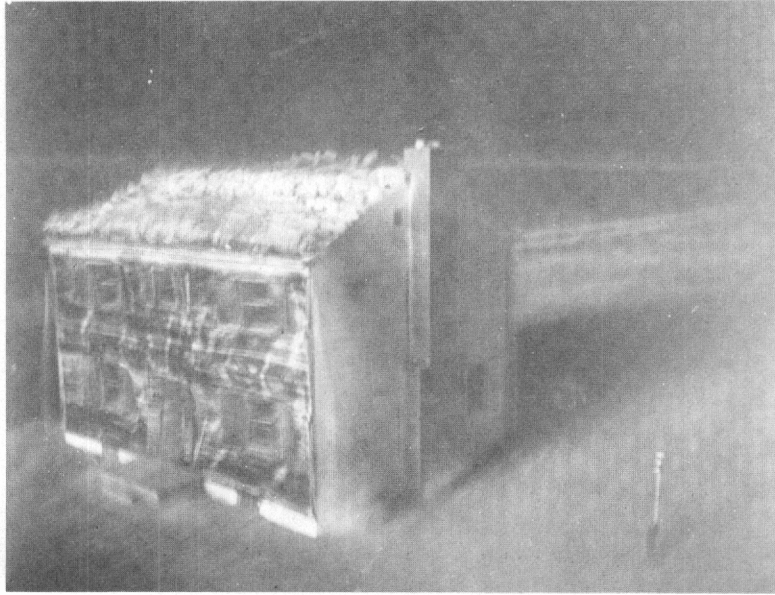
Fig. 1.5—House at 3500 ft,  $1\frac{3}{4}$  sec after detonation. The blast arrives. The front buckles, fragments fly from the roof, and the roof itself is ripped upward.

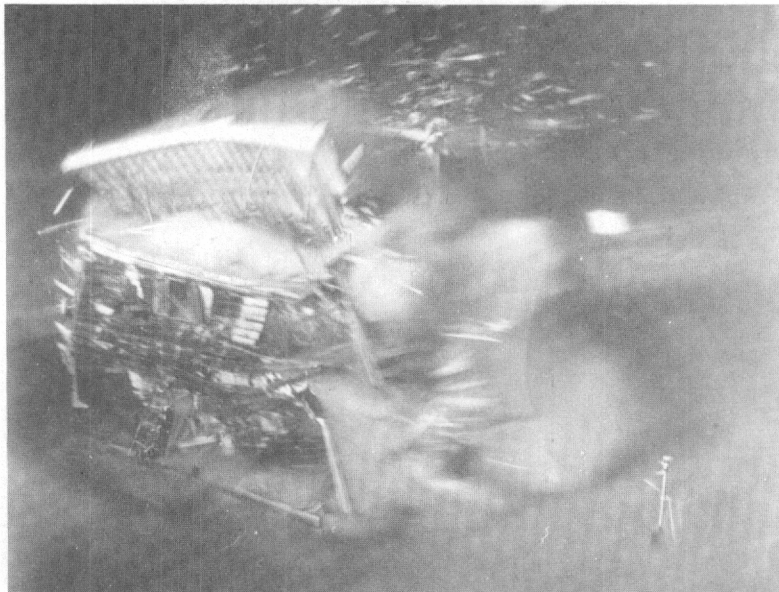
Fig. 1.6—House at 3500 ft,  $1\frac{22}{24}$  sec after detonation. The lower front wall is completely destroyed.

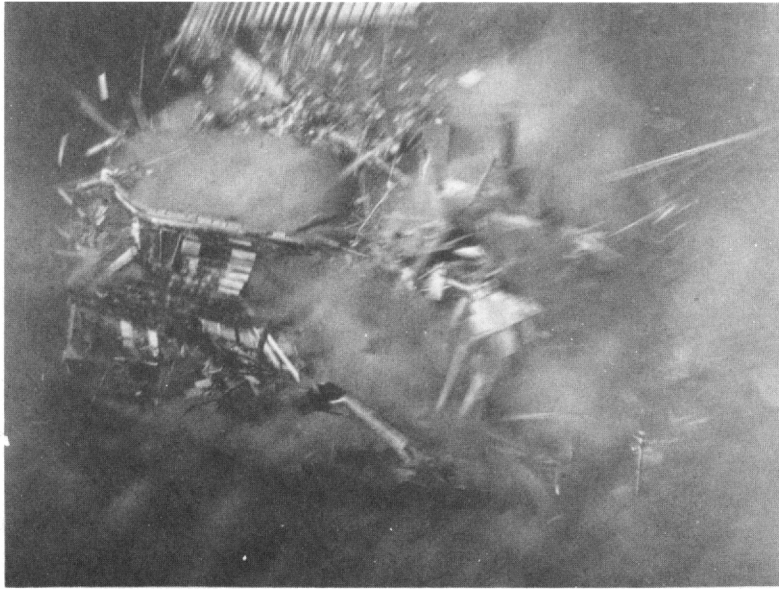
Fig. 1.7—House at 3500 ft,  $2\frac{3}{4}$  sec after detonation. The second story is being pushed back.

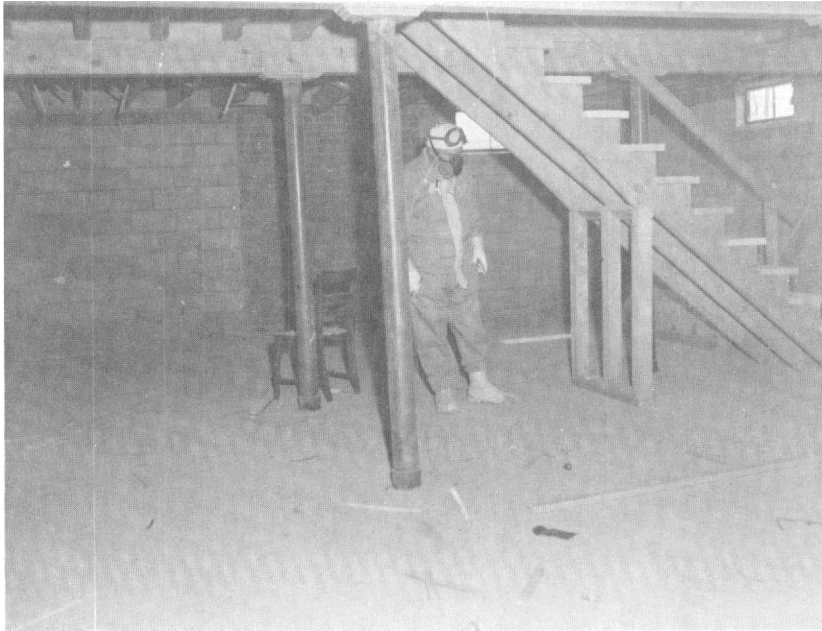
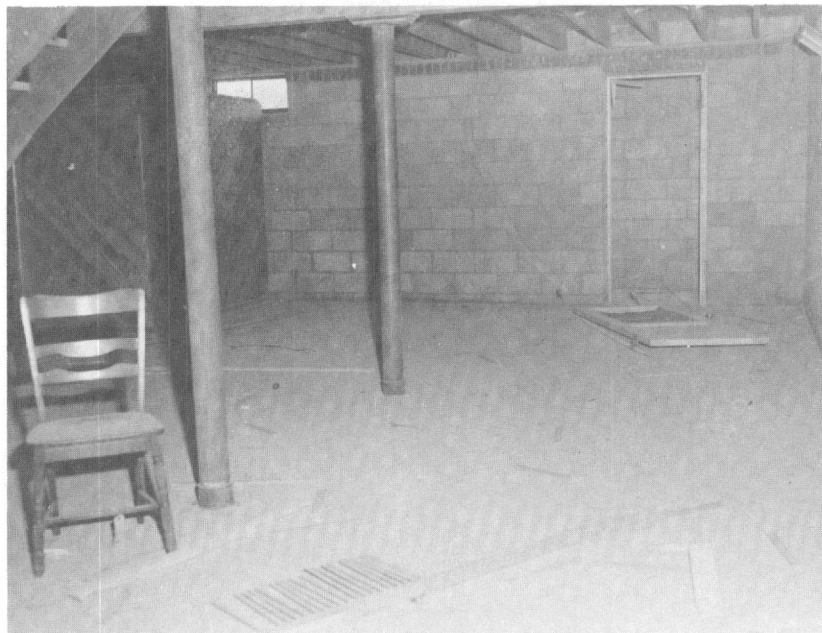
The basement was relatively free of debris except for that from the outside entrance doorway and suffered minor damage as shown in Figs. 2.7 and 2.8. The 6- by 8-in. wood girders, pipe columns, and most of the 2- by 8-in. floor joists of the first-floor system were undamaged. Figure 2.9 shows a split joist at about the third point under the kitchen. Figure 2.10 shows, under the dining room, the fourth joist from the front broken at a 4-in. knot, the fifth joist split, and the sixth broken at a 3-in. knot. Figures 2.11 and 2.12 show two views of the floor-joist damage under the living room. The joists framing into the double header were designed to be supported by steel joist hangers but were only spiked to the headers. These nails bent, allowing the supported joists to drop about 3 in. at the support, splitting one joist and pulling out the nails that secured the subflooring to the joists. The trimmers were shown on the architectural drawings as being doubled, but in the construction they were single joists and failed in horizontal shear in one and in bending in the other. Figure 2.11 also shows two other floor joists under the living room which failed in bending at approximately midspan.

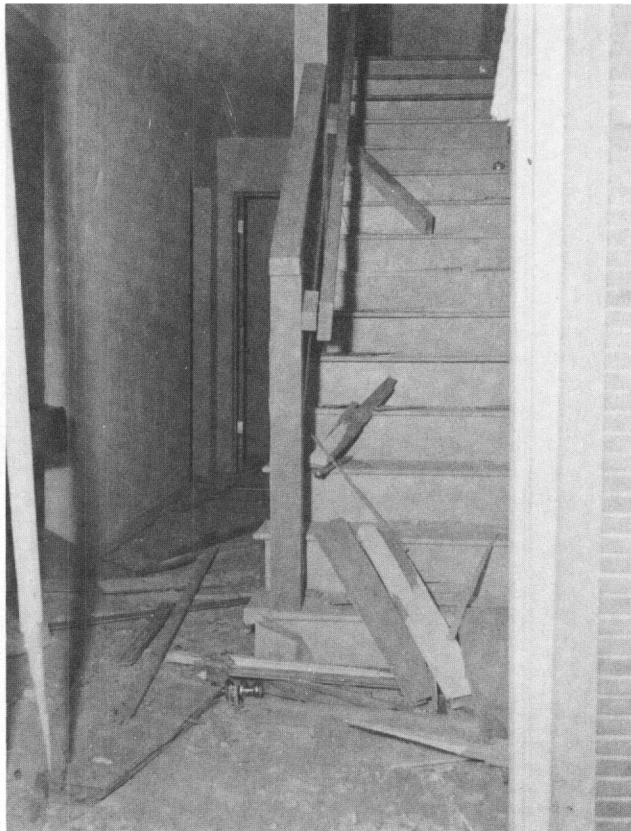
**Fig. 2.19—Entrance hall and stairs after the blast.**

Figure 2.19 shows the damage in the entrance hall on the first floor.

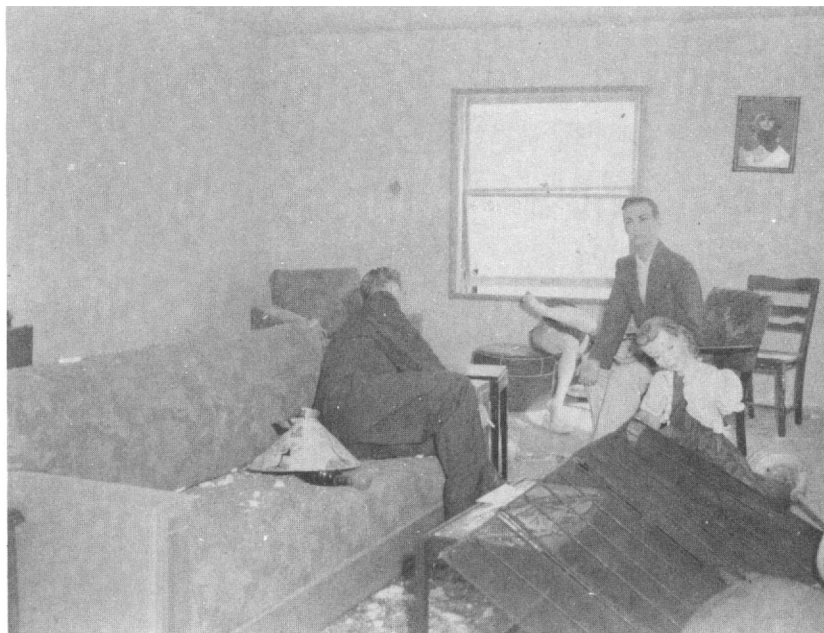
**Fig. 2.21—Living room after the blast.**

Figure 2.20 shows the living room before the blast; Fig. 2.21 shows a similar view of the living room after the blast. The child mannequin was found undamaged under the fireplace screen after the explosion but was removed before this photograph was taken. Figure 2.22 shows the rear end of the living room with the Venetian blind from the front window having been blown by the blast about 20 ft from its original position. Extensive damage to plaster and one broken first-story stud are shown in Fig. 2.23, which is a view of the front entrance taken from the living room. Plaster cracks around the fireplace indicated that there had been some deflection inward of the first-story studs in this side of the house.

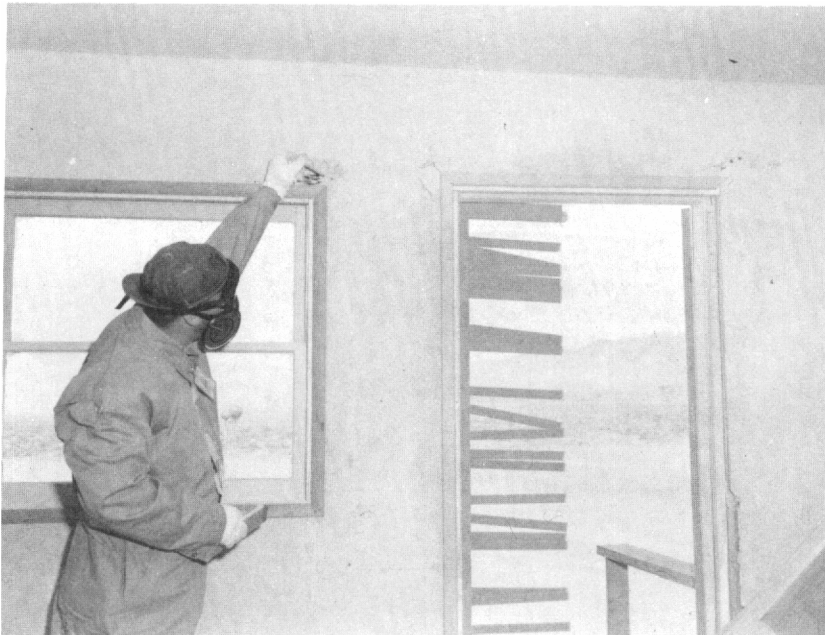
The kitchen in the rear of the house was protected somewhat by the partition wall between it and the dining room, yet furniture was thrown about, and the door to the dining room was broken and portions embedded in the plaster of the rear wall, as shown in Fig. 2.24. Figure 2.25 shows part of the kitchen-ceiling damage. The kitchen wall on the side of the house, between the door and window, bulged inward slightly, causing plaster cracks, as indicated in Fig. 2.26. The studs in this part of the wall may have been broken.

**Fig. 2.26—Kitchen entrance after the blast showing plaster cracks.**

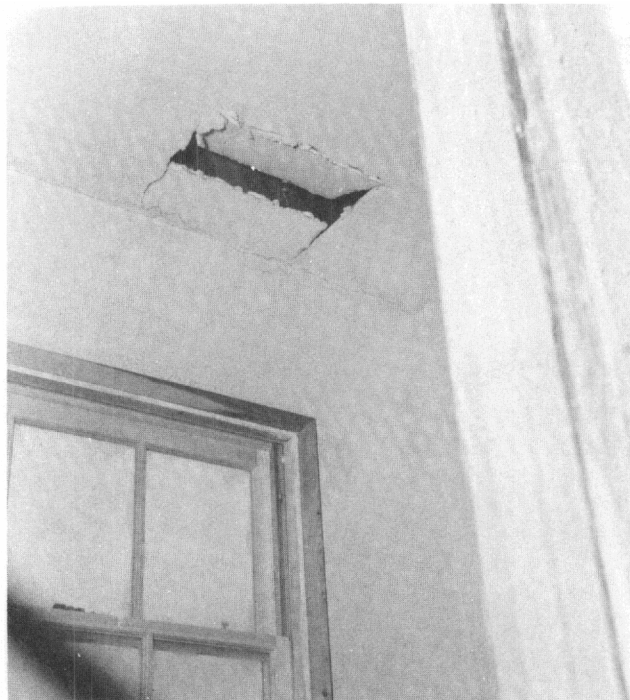
Figure 2.28 shows damage to first-floor lavatory ceiling, apparently caused by upward escape of pressure.

**Fig. 2.28—First-floor lavatory ceiling after the blast.**

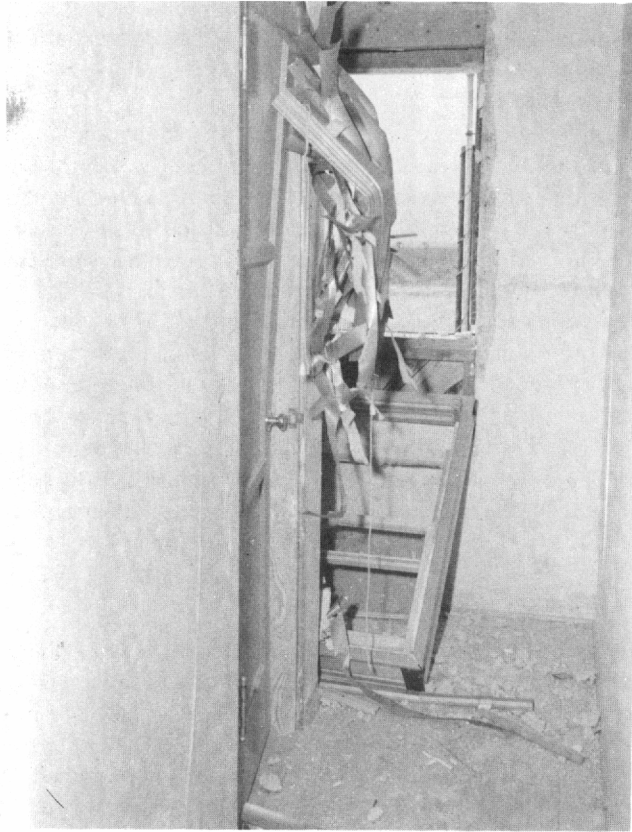
Figure 2.29 indicates what happened to the Venetian blind on the front window and the linen-closet door in the second-floor hall. The door was wedged in place by the bowing, and one slat of the blind was pinched between the top of the door and frame.

**Fig. 2.29—Damage to the second-floor hall at front.**

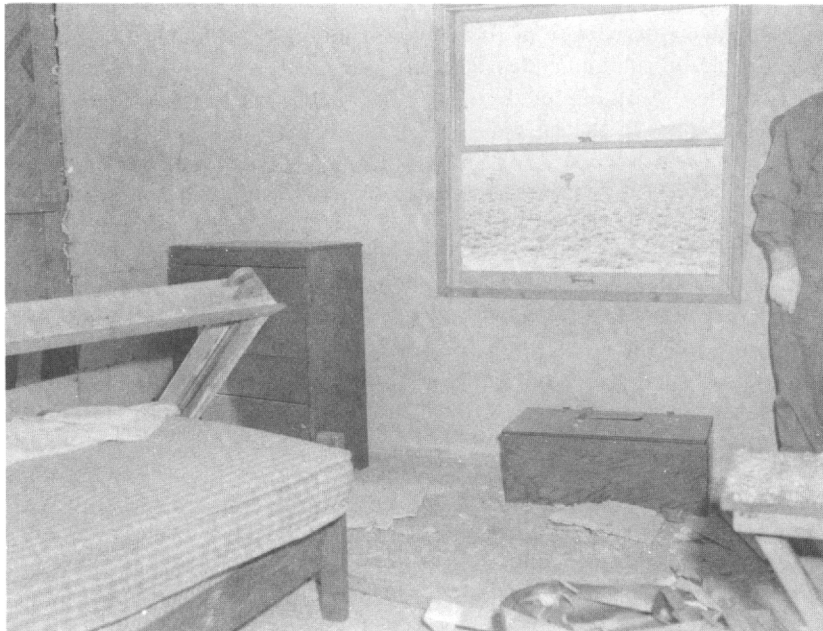
**Fig. 2.30—Front bedroom after the blast, looking toward the side.**

Figure 2.30 shows the front bedroom. To the left is shown one broken second-story stud, but from the horizontal plaster crack it is probable that the other studs split also. Plaster damage to the back wall of the front bedroom is shown in Fig. 2.31. The door to this room was open at the time of the explosion.

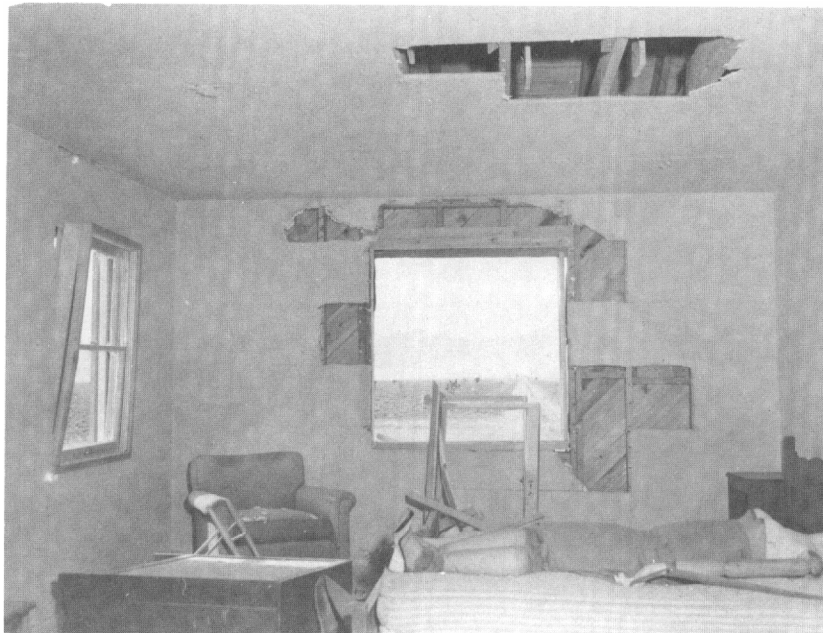
Figure 2.32 is a view of the master bedroom after the blast, looking toward Ground Zero. Deflection and splitting of the second-story studs in the front wall caused considerable plaster damage in this room. Damage to the ceiling may have been caused by unequal pressures in the attic and second story or by the weakening of the plaster due to the blast, with later removal by wind. The mannequin on the bed was not moved, but the covering was stripped from the bed.

**Fig. 2.32—Master-bedroom damage, looking toward the front.**

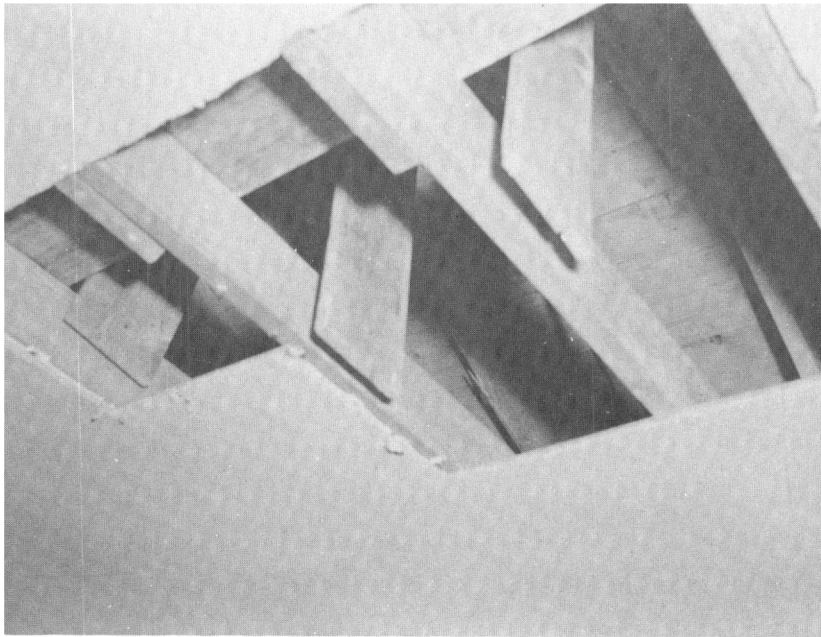
Figure 2.33 is a view of the front roof rafters taken through the hole in the master-bedroom ceiling. Only one broken roof rafter is visible. However, all roof rafters on the front of the house with the exception of one near the gable end were broken at approximately midspan (see Fig. 2.34). A photograph (Fig. 2.35) taken through a hole in the rear-bedroom ceiling shows the ridge board, which was carried down by the broken rafters in the front of the house, and the rear roof rafters that suffered no damage. Figure 2.36 shows damage to the south closet in the master bedroom and the Venetian blind from the front window of this room.

**Fig. 2.33—Master-bedroom ceiling damage.**

In the front of the house the 2- by 6-in. roof rafters, which were spaced 16 in. on centers, failed in bending at the middle of the span. While the size of these rafters is satisfactory for the usual static load, this test proved that, under blast loading, the roof construction was the weakest structural part of this house. No other structural portions failed so completely.

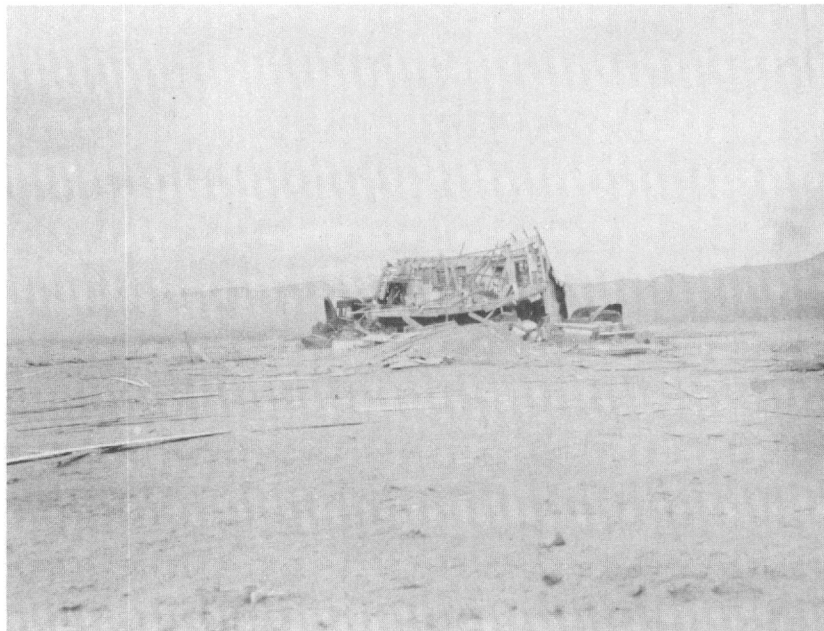
Figure 2.42 shows the large area over which debris was scattered. The front half of the roof broke in the middle at approximately the midspan of the rafters, the lower part lifting at the eaves, as shown by motion pictures, pivoting about the break, and sailing through the air to land on the ground in the rear of the house (see Fig. 2.43). The upper part of this broken roof was found upside down on the ground in front of the house, as shown in Fig. 2.44. The rear half of the roof slid off the house to the rear over a test automobile shown in Fig. 2.45. This section was later laid on the ground at the back of the house and can be seen in Fig. 2.43.

**Fig. 2.42—Debris from the house at 3500 ft.**

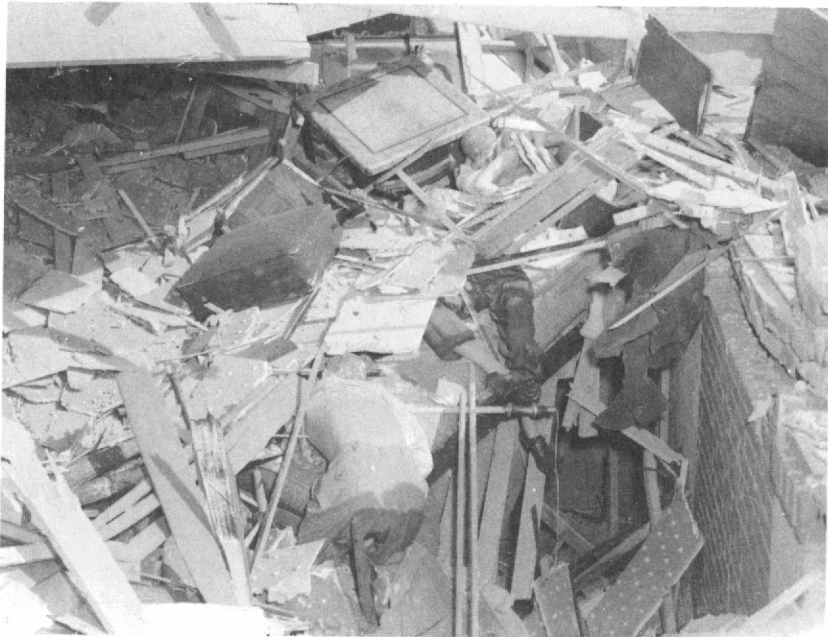
Figure 2.52 shows the living room with the store mannequins buried in the debris. This part of the first floor sagged into the basement space, as shown in Fig. 2.53, which is a view of the underside of the living-room floor from the rear part of the basement.

**Fig. 2.52—Living room from the front of the house.**

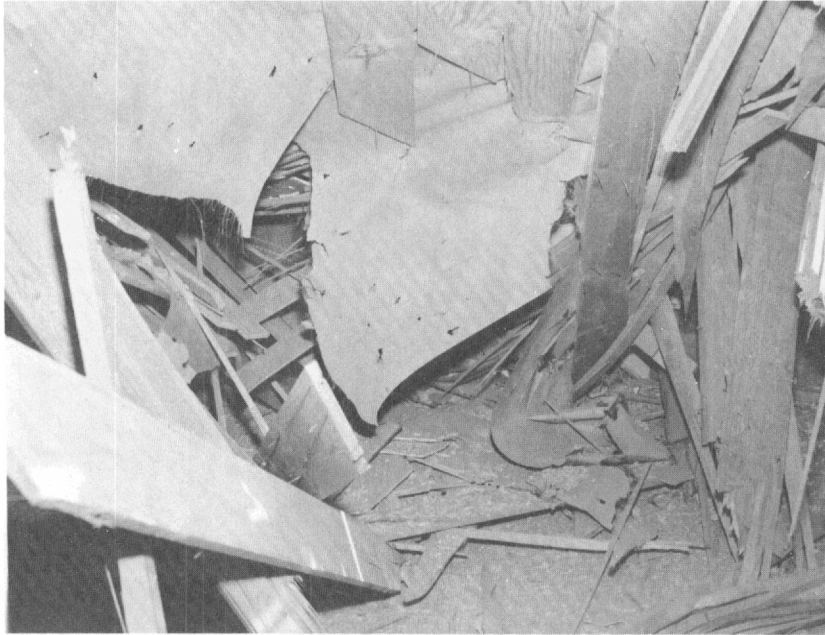
**Fig. 2.53—Underside of the living-room floor.**

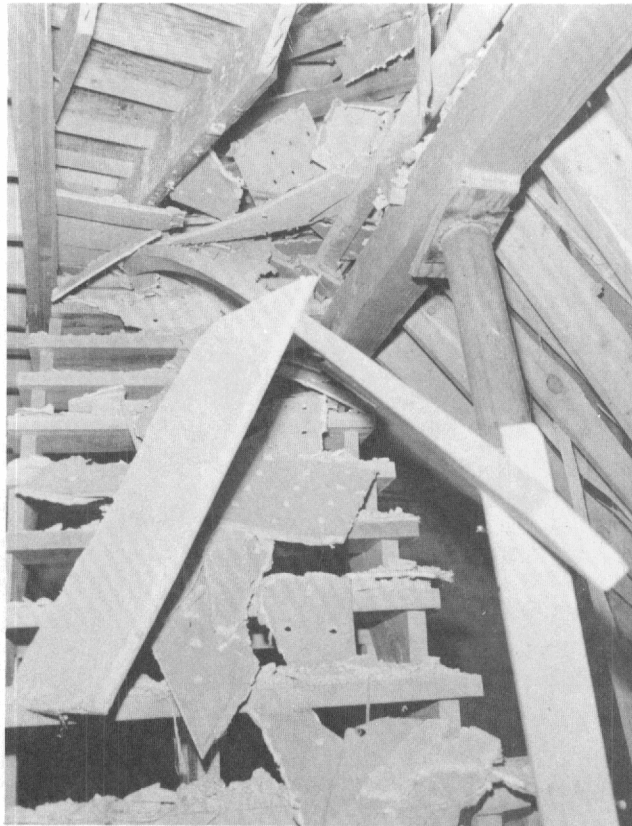
**Fig. 2.54—Basement stairs, showing position of upper flight.**

Figure 2.54 shows how the stairs from the first to the second floor collapsed into the basement stairwell when the second story dropped on the first floor.

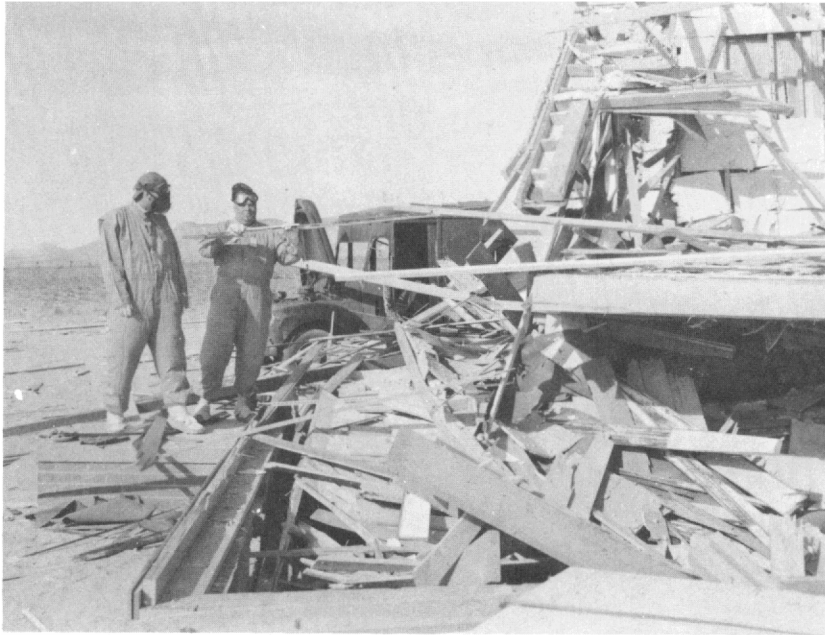
**Fig. 2.55—Rotation and movement of the second story at front.**

The second story did not drop vertically on the first floor but moved with a clockwise rotation in relation to the front basement wall of the house. The right front corner of the second floor settled 5 ft 8 in. from the front and 8 ft 3 in. from the right-side basement wall, while the left front corner of the second floor was 12 ft from the front basement wall and overhung the left-side basement wall by 10 ft 2 in. The motion appeared to be a rotation and a movement toward the left rear corner of the foundation wall. This is shown in Fig. 2.55.

The box-sill construction used at the top of the block foundation wall failed. Generally, the 2- by 8-in. plate, which was bolted to the block wall, remained in place. In the front of the house, the 2- by 8-in. closure or header split at the top horizontally, with the top portion moving with the first floor and the lower portion remaining with the plate, as shown in Fig. 2.55. At the sides of the house, where the closure was nailed into the ends of the floor joists, the nails bent, allowing the joists to slide to the rear of the house with the floor and separating the closure from the plate. This is also illustrated in Fig. 2.55.

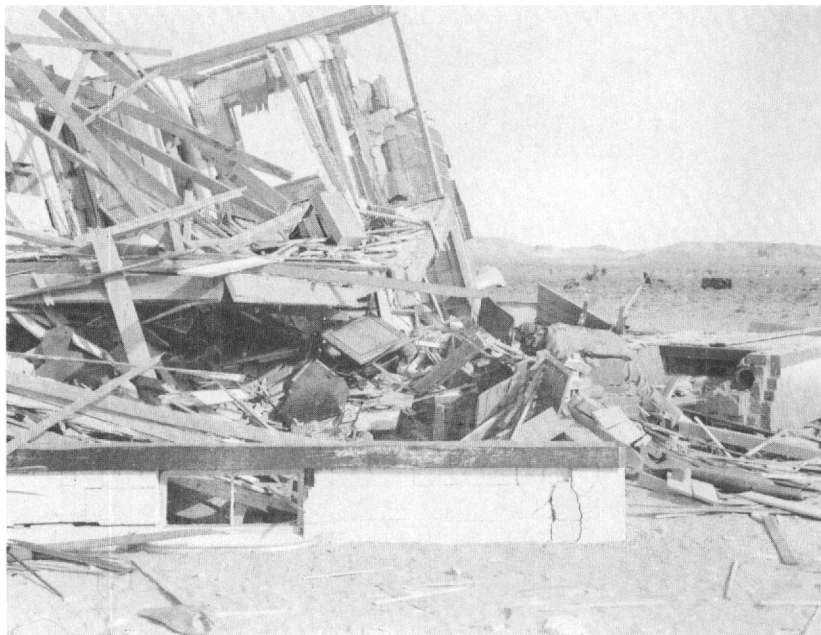
**Fig. 2.57—Front foundation wall above grade after the blast.**

The foundation wall above grade suffered little damage on the front and sides but was damaged at the rear by the movement of the first-floor system. However, the front foundation wall (Fig. 2.57) was cracked through vertically from sill to basement floor at each end, about 1 ft from the corner, and was moved in at the top about 1 in., hinging at the basement floor level. The hinged wall showed no bowing or cracking, however. Lateral earth pressure due to the pressure on the ground in front of the house was the most probable cause of this effect.
